LINK COPPER

PUXADORES E ACESSÓRIOS /
LEVER HANDLES AND ACCESSORIES /
MANILLAS Y ACCESORIOS.

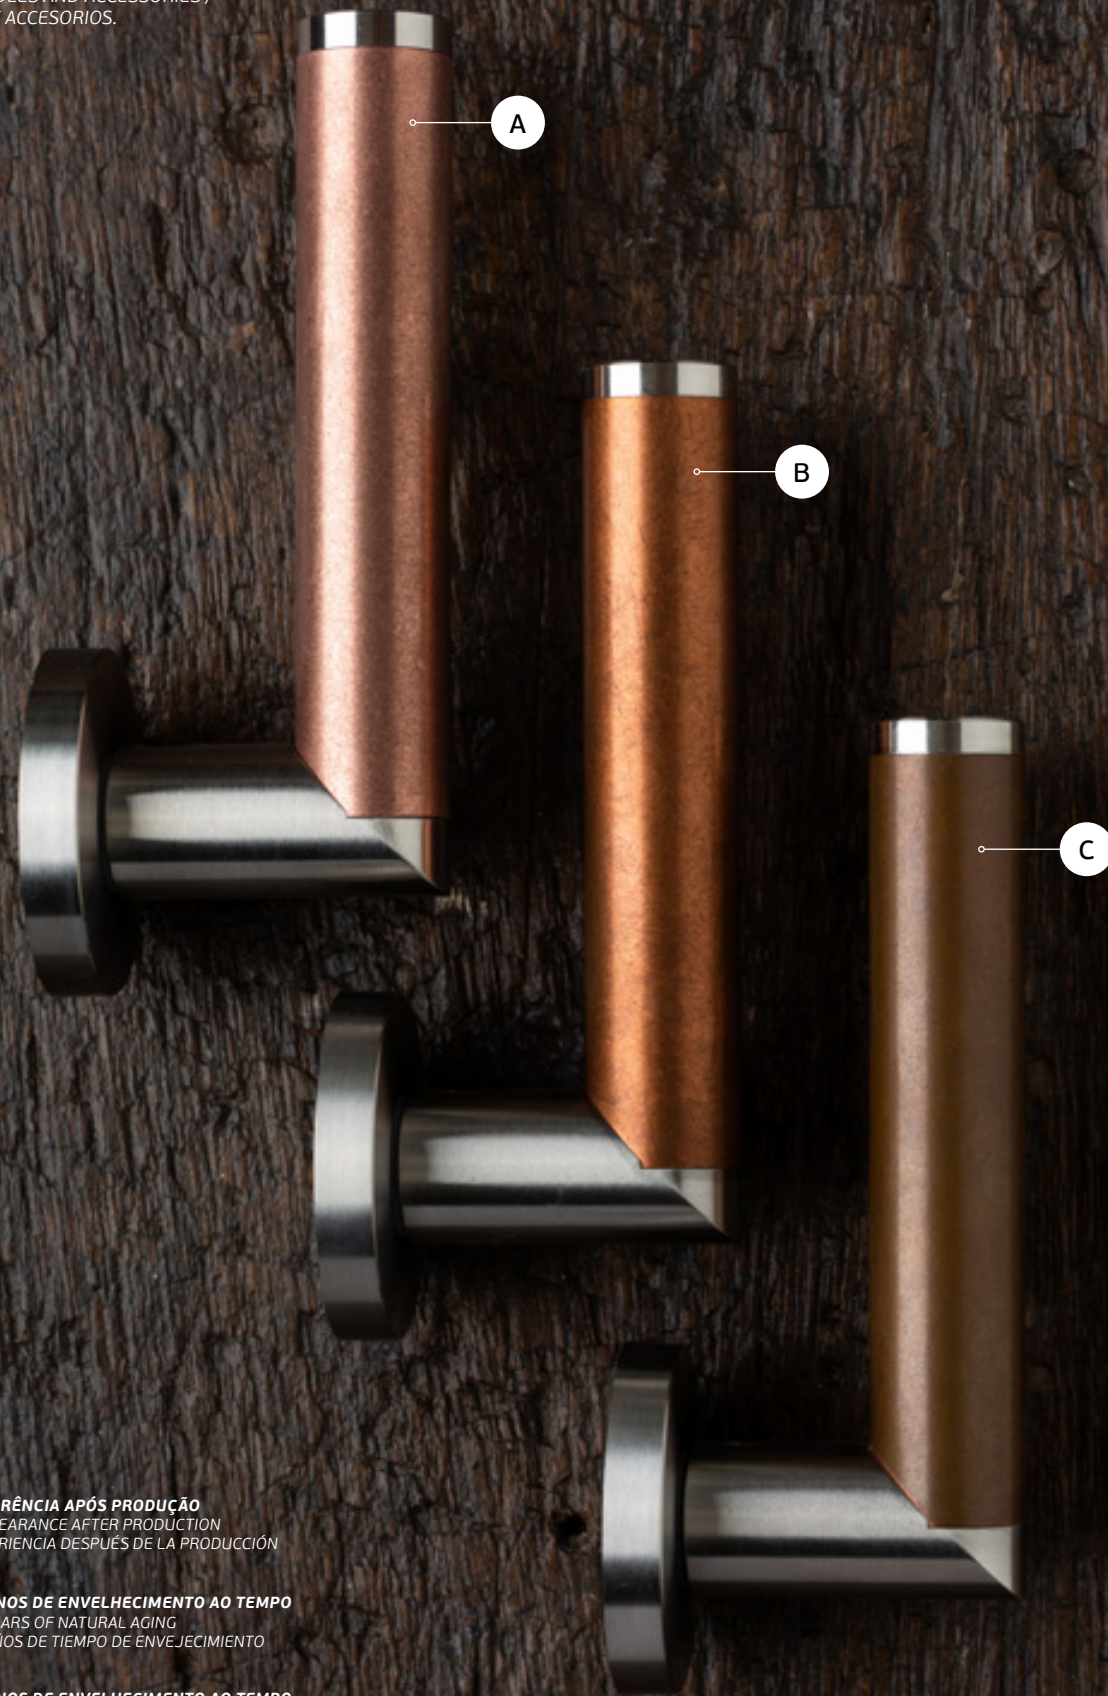
A APARÊNCIA APÓS PRODUÇÃO
APPEARANCE AFTER PRODUCTION
APARIENCIA DESPUÉS DE LA PRODUCCIÓN

B 3 ANOS DE ENVELHECIMENTO AO TEMPO
3 YEARS OF NATURAL AGING
3 AÑOS DE TIEMPO DE ENVEJECIMIENTO

C 5 ANOS DE ENVELHECIMENTO AO TEMPO
5 YEARS OF NATURAL AGING
5 AÑOS DE TIEMPO DE ENVEJECIMIENTO

PÁTINA NATURAL
A PEGA DE COBRE DO PUXADOR
PROPOSITADAMENTE NÃO TEM TRATAMENTO DE
SUPERFÍCIE, PARA QUE POSSA DESENVOLVER A SUA
PRÓPRIA PÁTINA AO LONGO DO TEMPO CONFORME O
USO E O AMBIENTE ONDE ESTÁ INSERIDO.

NATURAL PATINA
THE HANDLE COPPER PART DOESN'T HAVE A SURFACE
COATING ON PURPOSE, SO IT CAN DEVELOP ITS OWN
PATINA OVER THE TIME ACCORDING TO THE USE AND THE
ENVIRONMENT WHERE IT IS INSERTED.

PATINA NATURAL
EL ASA DE COBRE DE LA MANILLA NO TIENE
TRATAMIENTO DE SUPERFÍCIE, PARA QUE PUEDA
DESARROLLAR SU PROPIA PATINA A LO LARGO DEL
TIEMPO SEGÚN EL USO Y EL AMBIENTE DONDE ESTÁ
INSERTADO.

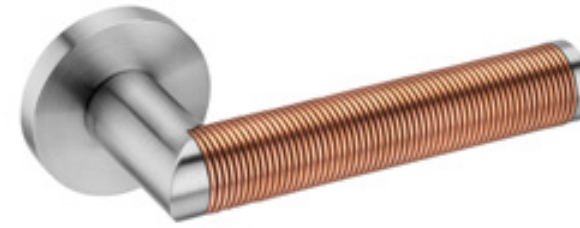
IN.00.406 LINK COPPER WIRE
Puxador de porta /
Door lever handle / Manilla de puerta
RC08M (Roseta standard / Standard rose)

MATERIAL: EN 1.4301 / AISI 304

ACABAMENTO / FINISH / ACABADO:
STANDARD: SATINADO + COPPER /
SATIN + COPPER / SATIN + COPPER

OPTIONAL: PVD TITANIUM COATED

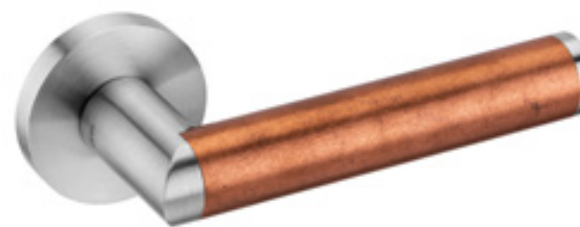
IN.00.409 LINK COPPER
Puxador de porta /
Door lever handle / Manilla de puerta
RC08M (Roseta standard / Standard rose)

MATERIAL: EN 1.4301 / AISI 304

ACABAMENTO / FINISH / ACABADO:
STANDARD: SATINADO + COPPER /
SATIN + COPPER / SATIN + COPPER

OPTIONAL: PVD TITANIUM COATED
